Property Inspection Report

Property Address
321 Test Street
Brighton
BN12345

Inspection Date
22 April 2026

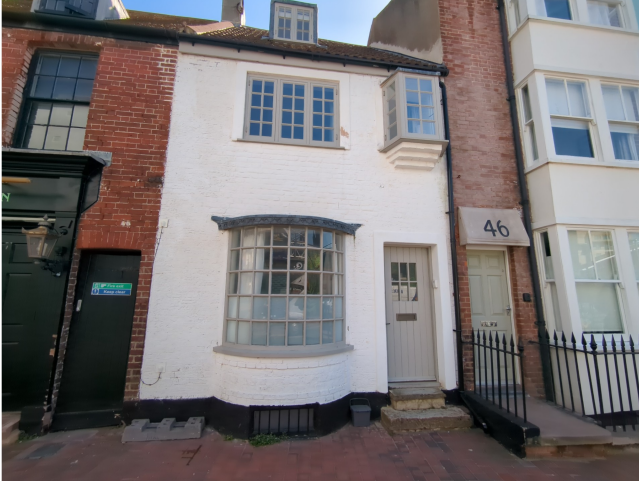
5.1.1 Exterior 1 Overview

The exterior of the property is generally in good condition, although some render repairs are necessary. The paint around the window requires touch-up to maintain the aesthetic quality.

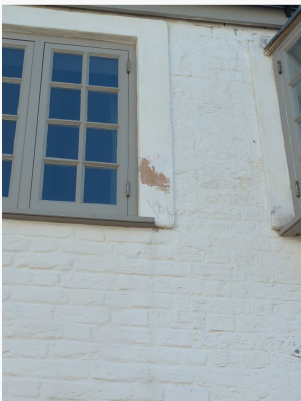
The paint surrounding the window requires touch-up to enhance the exterior appearance.

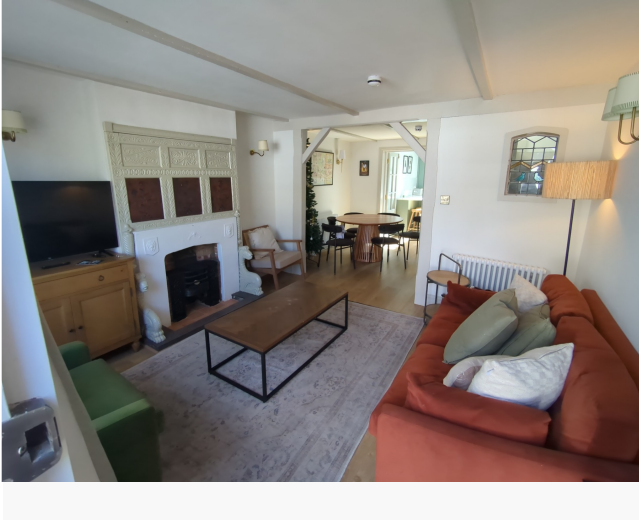
5.2.1 Living Room 1 Overview

The living room is in excellent condition with no issues detected during the inspection.

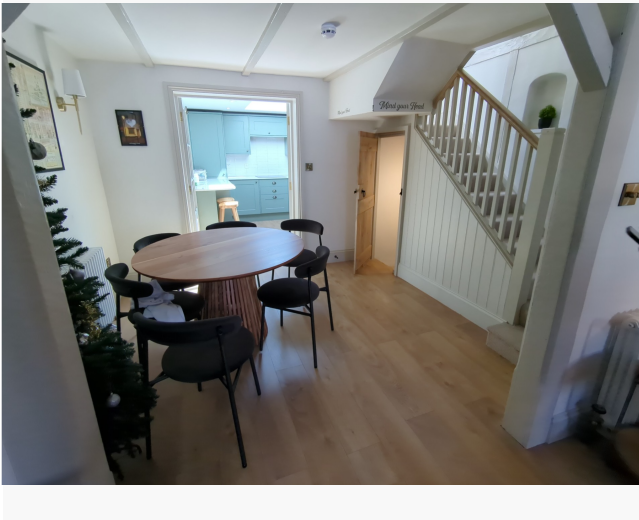
5.3.1 Dining Room 1 Overview

The dining room is well-maintained, though one light bulb requires replacement to ensure full functionality.

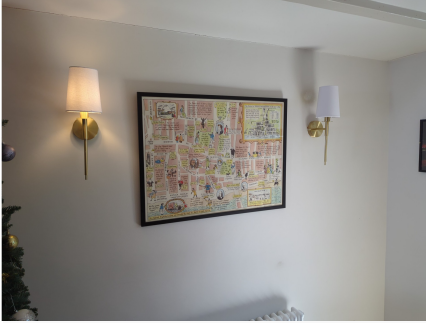
A light bulb is non-functional and requires replacement to restore full lighting capability.

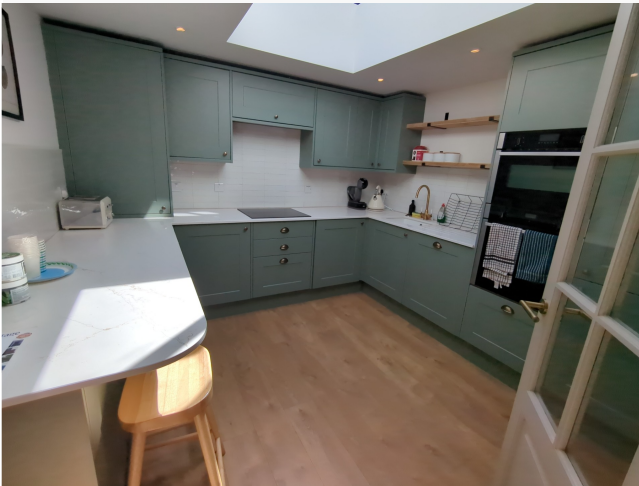
5.4.1 Kitchen 1 Overview

The kitchen is in good condition overall. However, potential water damage from a leak above and a small plaster defect require further investigation.

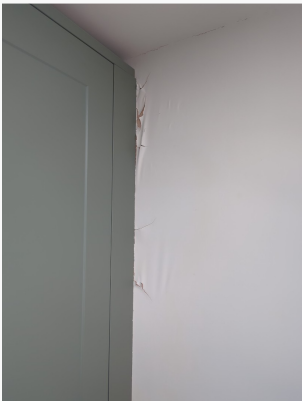
Potential water damage is evident from a leak above, necessitating further investigation.

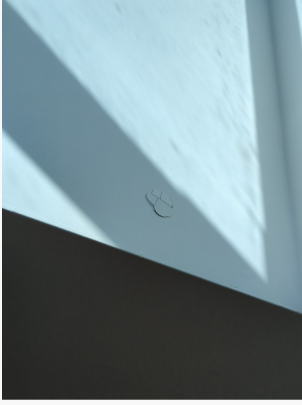
A small section of plaster is detaching from the ceiling at head height, requiring attention.

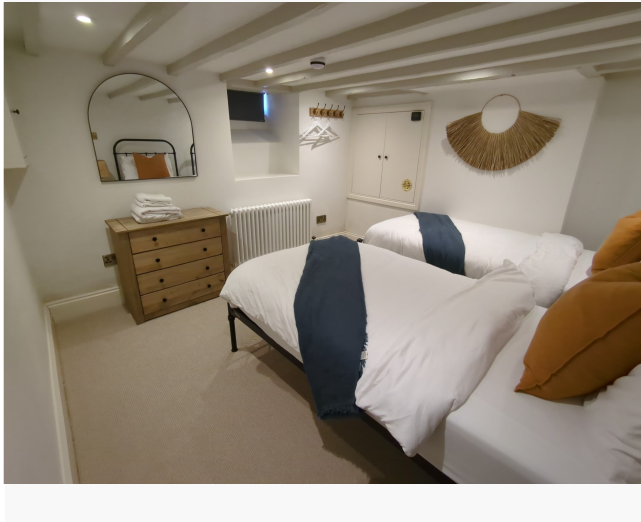
5.5.1 Bedroom 1 Overview

The bedroom shows a small amount of damp in the corner, which should be addressed to prevent further issues.

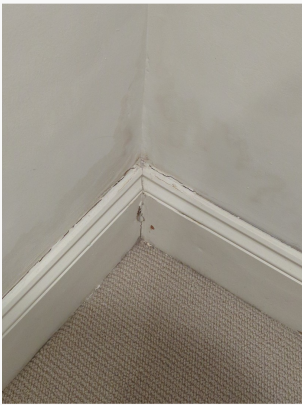
A minor presence of dampness is observed in the room's corner, warranting remediation.

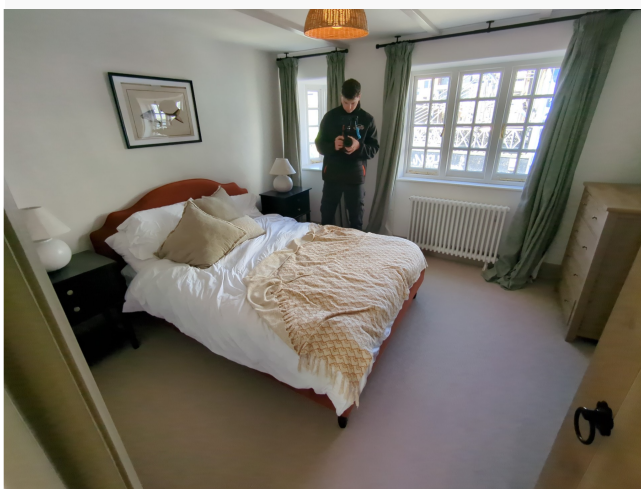
5.5.2 Bedroom 2 Overview

Bedroom 2 is in excellent condition with no maintenance issues observed.

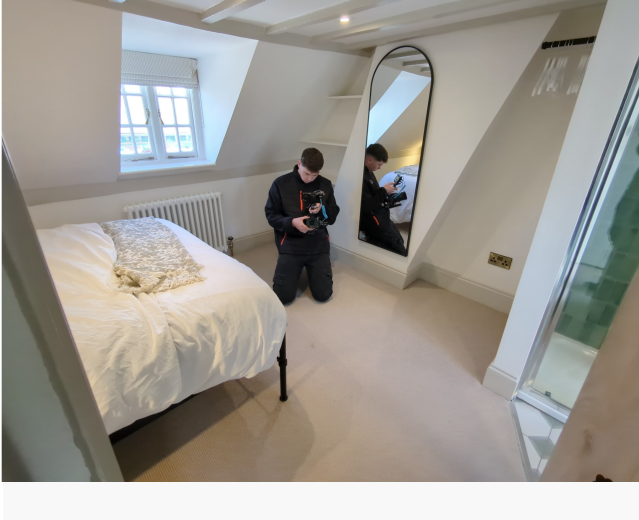
5.5.3 Bedroom 3 Overview

Bedroom 3 is in good condition with no major issues noted.

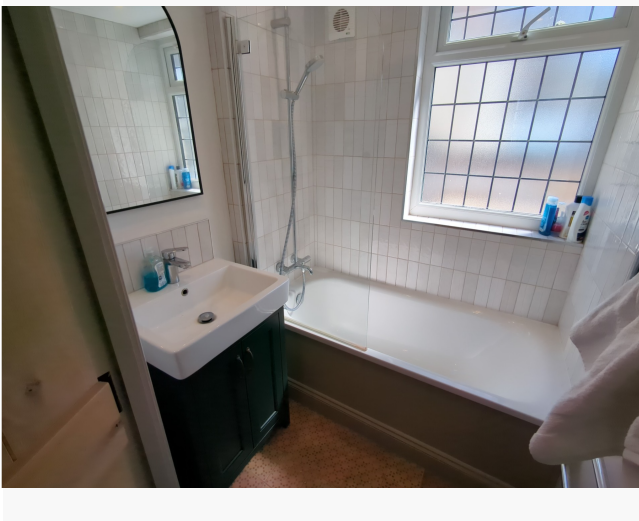
5.6.1 Bathroom 1 Overview

The bathroom is in excellent condition overall, though the tap is dripping and requires plumbing attention.

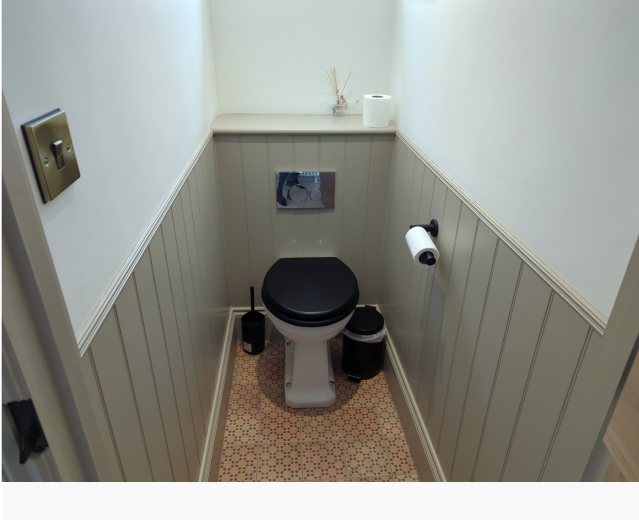
5.7.1 Toilet Overview

The toilet is in good condition, with minor peeling paintwork on the back wall that requires cosmetic attention.

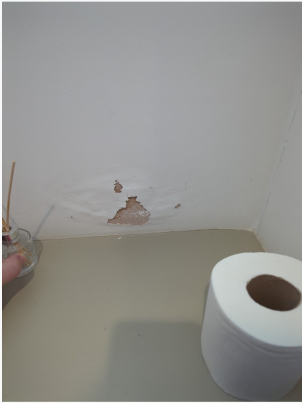
The paint on the back wall behind the toilet is peeling and requires cosmetic repair.

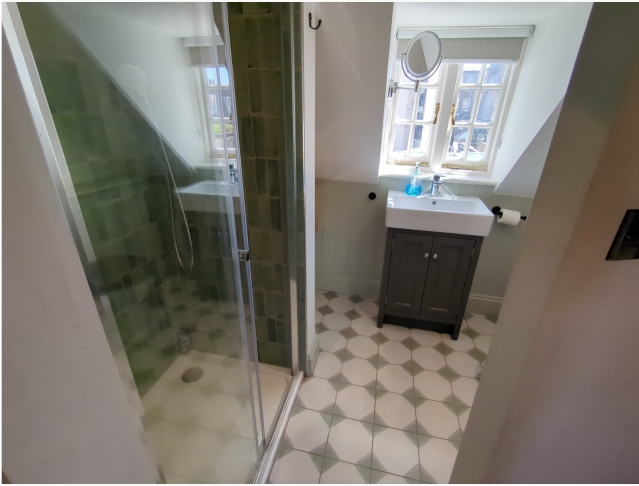
5.8.1 Ensuite 1 Overview

The ensuite is in good condition, though there is dirt around the drain that may indicate slow drainage.

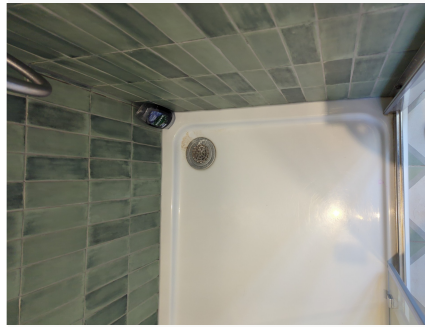
Dirt accumulation around the drain suggests potential slow drainage, requiring cleaning.
